BLACKSTONE RIVER BASIN
AUBURN, MASSACHUSETTS

PONDVILLE DAM

MA. 00197

PHASE I INSPECTION REPORT
NATIONAL DAM INSPECTION PROGRAM

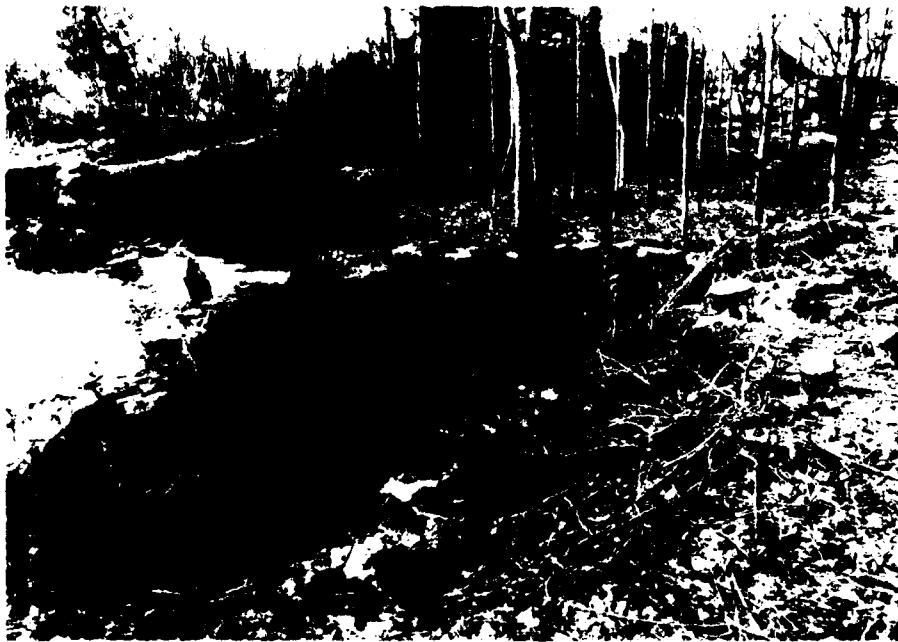
A section on the left side of the embankment adjacent to the right training wall of the spillway has eroded away severely, resulting in a void approximately 6 ft. wide by 10 ft. long, as shown in photo nos 4 and 5. The bottom of the void in the embankment extends downward to the base of the right training wall of the spillway where there is a void in the training wall as shown in photo nos 6 & 10. Clear seepage was noted coming through the dam below this void. It was not possible to make an estimate of the quantity of flow. This section of the dam is in extremely poor condition, as a significant section of the embankment upstream of the wall has eroded away and the remaining portion is "hanging by a thread". Clear seepage was observed in the void but could not be estimated because of heavy brush growth.

4. Void in upstream embankment at right spillway training wall. (Photo taken 2 March 1981).

c. Urgency. The recommendations and remedial measures enumerated below should be implemented by the owner within one year after receipt of this Phase I Inspection Report except the investigations of the void at the left end of the embankment and the void at the toe of the right spillway training wall should be carried out upon receipt of this report.

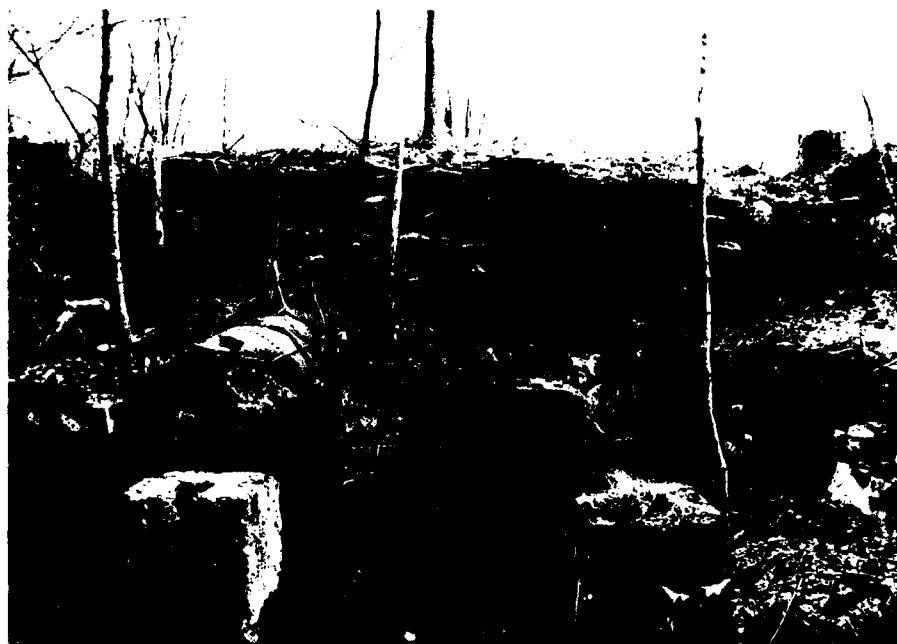
9. Downstream view of 3 ft. dia. pipe extending from downstream face of dam (Photo taken 2 March 1981).

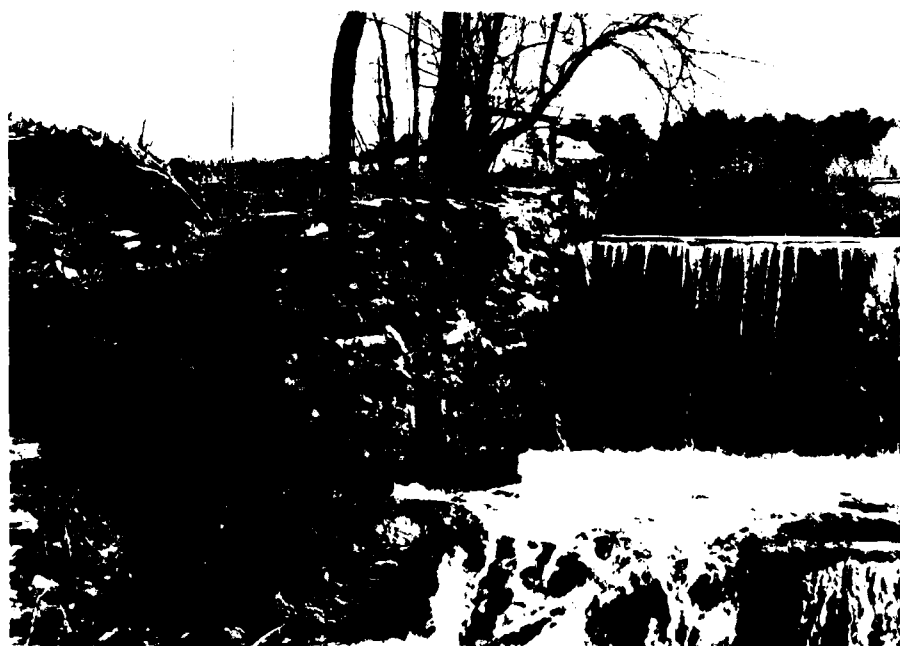
10. Downstream view of right spillway training wall. (Photo taken 2 March 1981)

(3) Repair the training wall on the left side of the spillway.
